2021

State of the McKenzie Watershed Report

Eugene Water & Electric Board

February 2022

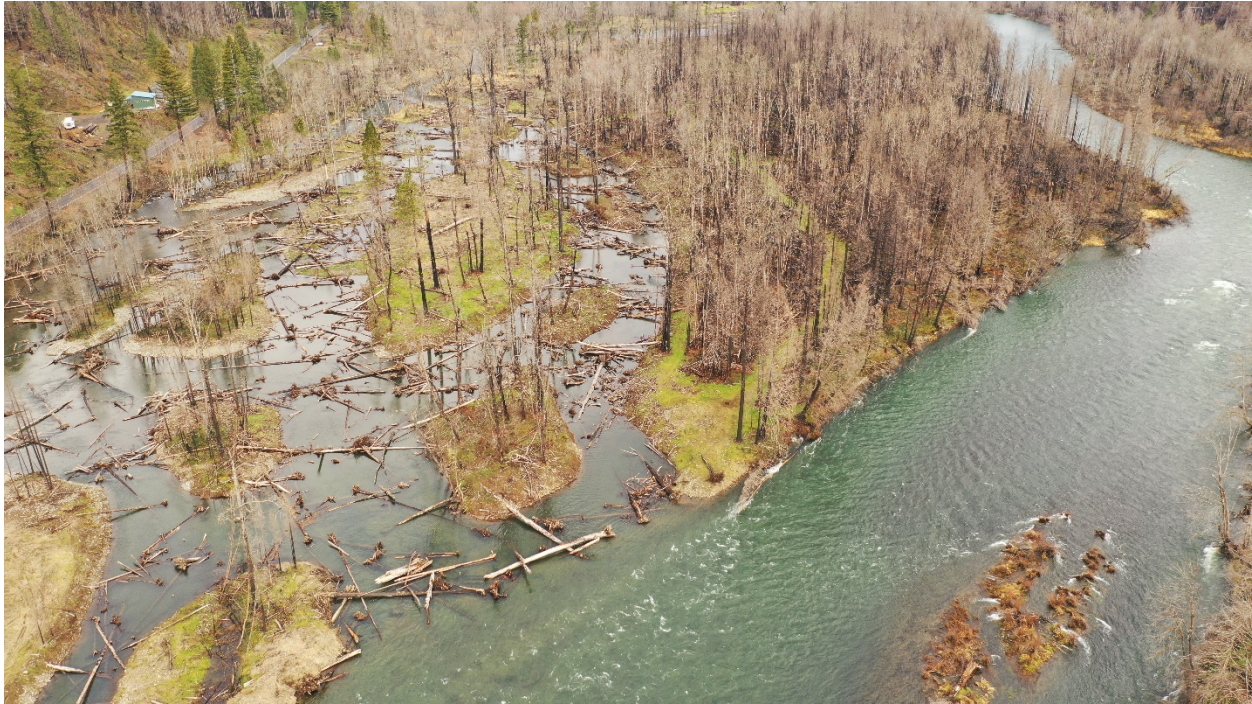
Figure 1-2: Finn Rock Floodplain Restoration Area (drone shot courtesy of Brent Ross with McKenzie River Trust)

We continue to work with The McKenzie Watershed Council, the McKenzie River Trust, and the U.S. Forest Service (USFS) to implement large-scale floodplain restoration in Deer Creek and Finn Rock with an eye towards other watersheds like Quartz and Ennis Creek in the coming years. This type of restoration can mitigate floods, turbidity, and organic carbon by spreading out and attenuating flows, dropping out sediment, and increasing the uptake of nutrients and organic carbon coming from upstream severely burned landscapes. These projects also have numerous co-benefits including water storage, increasing habitat for fish and wildlife, protection from fire, and increasing cold water refugia.

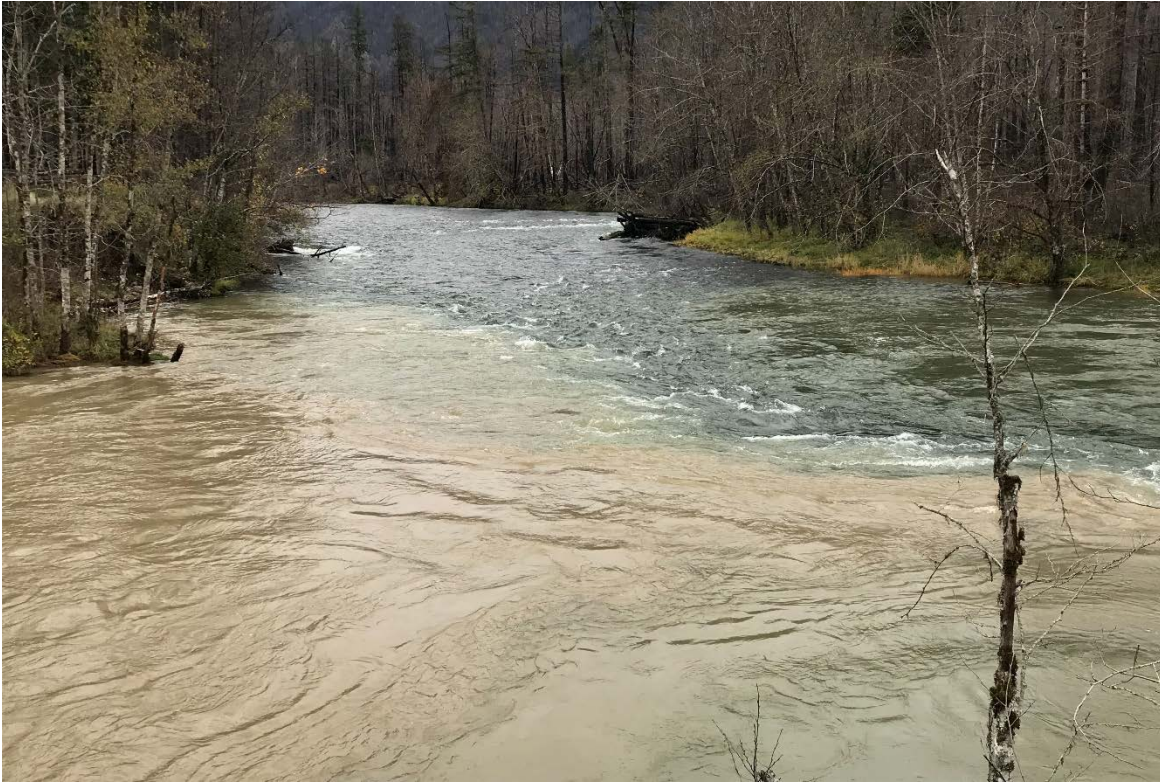
Reservoir operations by the Corps of Engineers in Blue River Reservoir brought the lake level down rapidly in November. However, water levels fell below the water control diagram at one point, exposing lakebed sediments to the scouring forces of channel flow. The result was a dramatic rise in turbidity levels downstream in both Blue River and the McKenzie River. Turbidity levels (the cloudiness of the water) in Blue River reached values above 500 Formazin Nephelometric Units (FNU) which rivals some of the highest turbidity values observed immediately after the Holiday Farm Fire during storm events. Increased turbidity was observed in the McKenzie River (Figure 1-3) all the way down to Hayden Bridge for several days.

Figure 1-3: Major Turbidity Event in Blue River (McKenzie in background/Blue River in foreground)

Similar to 2020, most peak values observed in 2021 were associated with prolonged rain events in urban areas of eastern Springfield or within the HFF area. An important departure from previous years was the Blue River Reservoir turbidity event this past November. Samples collected during this unusual event resulted in some of the highest values ever observed by Source Protection staff in the McKenzie Watershed for several analytes. Fortunately, the event was relatively short-lived and only lasted for a few days.

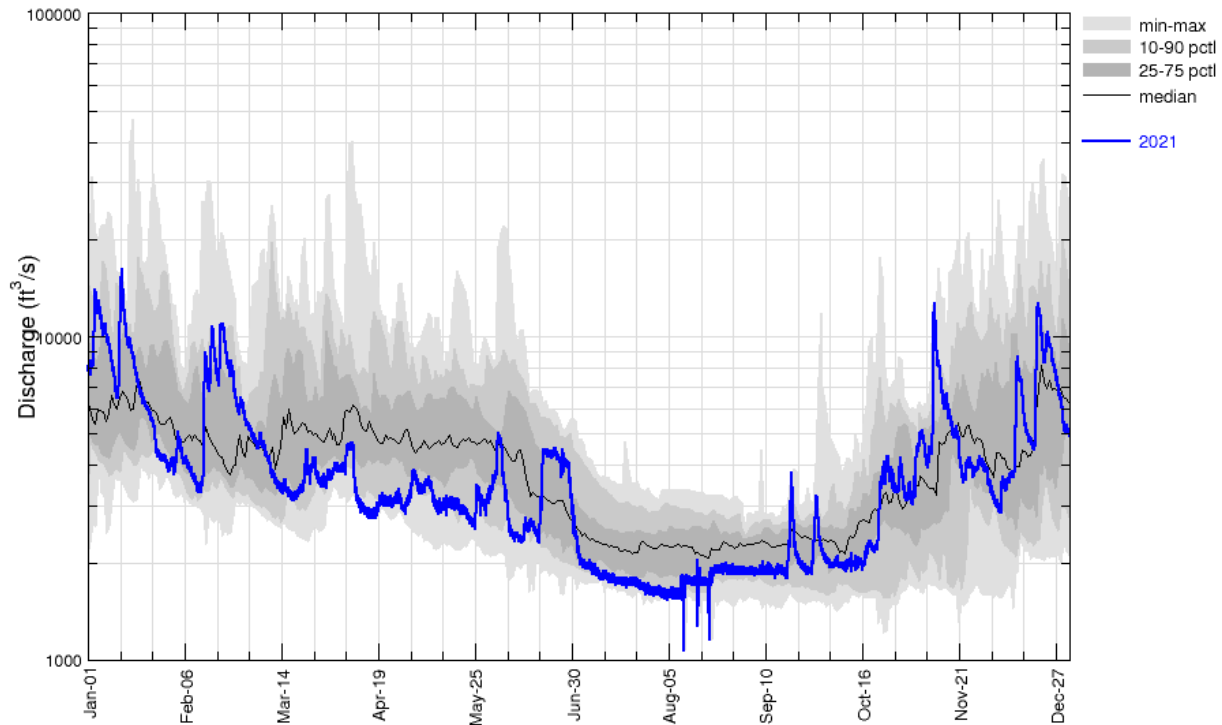
McKenzie River abv Hayden Bridge at Springfield, OR (14164900)

McKenzie River flow at Hayden Bridge during the 2021 calendar year was generally below historical median flows (see Figure 2-1). Flows approached historical minimum levels during the month of April, and again in July/August, but eventually climbed closer to median flows later in the fall. The highest flow observed at Hayden Bridge during 2021 was 16,100 cubic feet per second (cfs), which occurred on January 13th.

Data from U.S. Geological Survey, Mar-21-2007 to Jan-27-2022

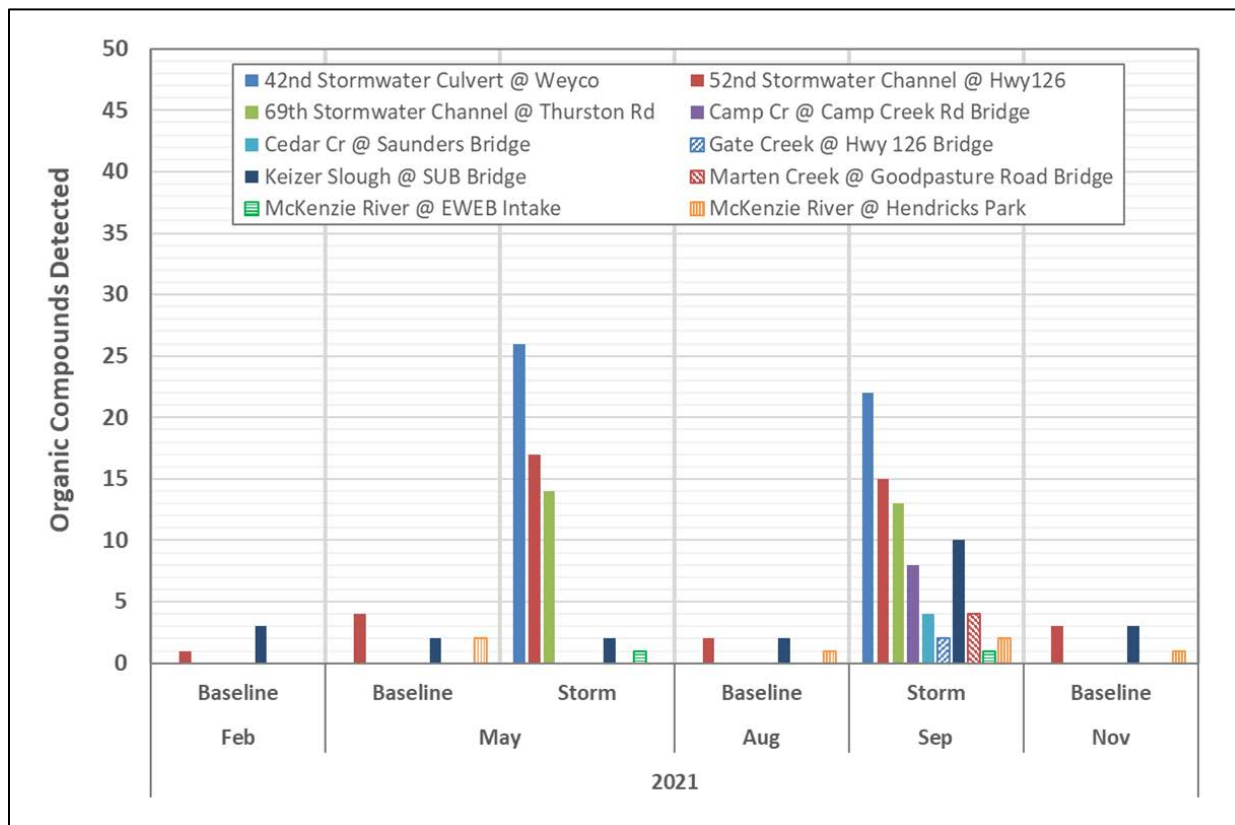
Figure 3-7: Organic Compounds Detected Above Method Reporting Limits by Site, 2021.

outfalls, as well as for Keizer Slough, were also elevated during these events. Both events captured runoff conditions in urban areas after considerable dry periods.

Table 3-1 summarizes total detections across all sites for multiple organic compound groups. Several key observations related to the organics data are worth pointing out. First, almost all of the detections are considered low level, and often less than 1 ug/L. Second, several per- and polyfluorinated substances (PFAS) were detected in multiple stormwater outfalls, particularly during large storm events. Low-level PFAS compounds have previously been detected in urban stormwater outfalls in prior years. Third, a broad-screen pharmaceutical and personal care product (PPCPs) method was used at multiple sites in 2021. This PPCP method provides very low-resolution detection of organic compounds in surface water and may account for the uptick in detections. Fourth, with a heavy focus on pesticides and semi-volatile organic compounds (SVOCs) this past year, numerous pesticides were detected, primarily in stormwater outfalls. While most pesticide detections are generally regarded as low level (<1 ug/L), there was a relatively high hit of glyphosate (55 ug/L) in the 52nd stormwater channel back in September 2021. However, it is also worth noting that the Federal maximum contaminant level (MCL) for glyphosate in drinking water is 700 ug/L, which is well above the concentration detected in the stormwater channel.

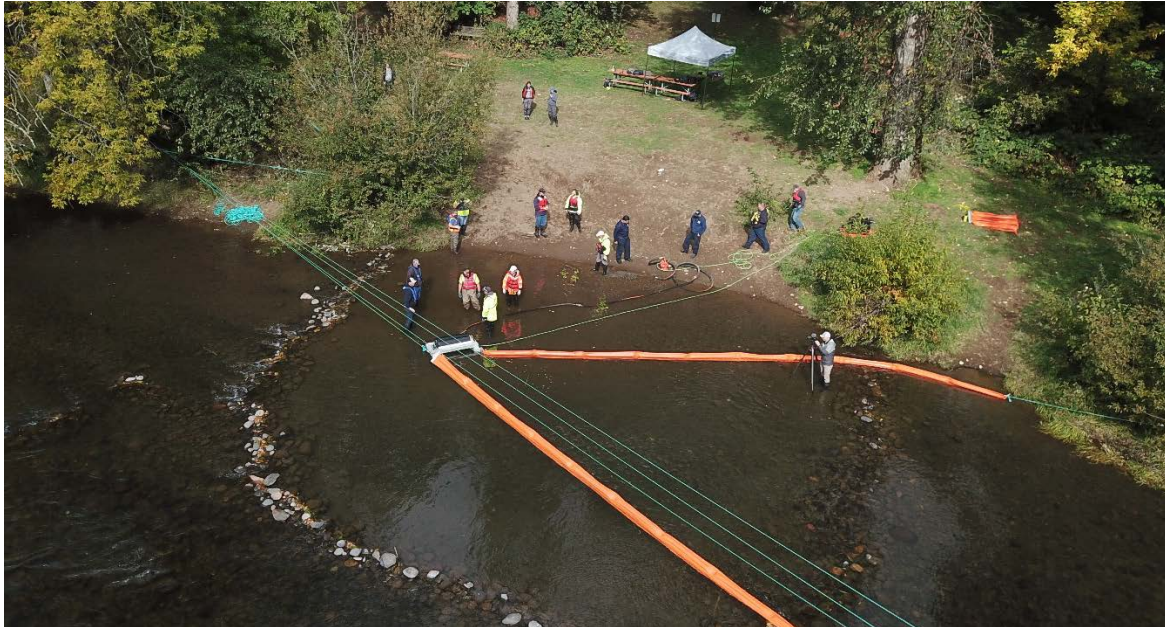
EWEB worked with multiple partners to coordinate a multi-agency spill response drill on the McKenzie River this past fall (see Figure 4-1). Equipment from the McKenzie Watershed Emergency Response System (MWERS) was used to deploy boom across a segment of the river. The drill gives first responders an opportunity to familiarize themselves with equipment and to test out new response strategies.

Figure 4-1: Boom Deployment Drill, McKenzie River at Hendricks Bridge Park, 2021

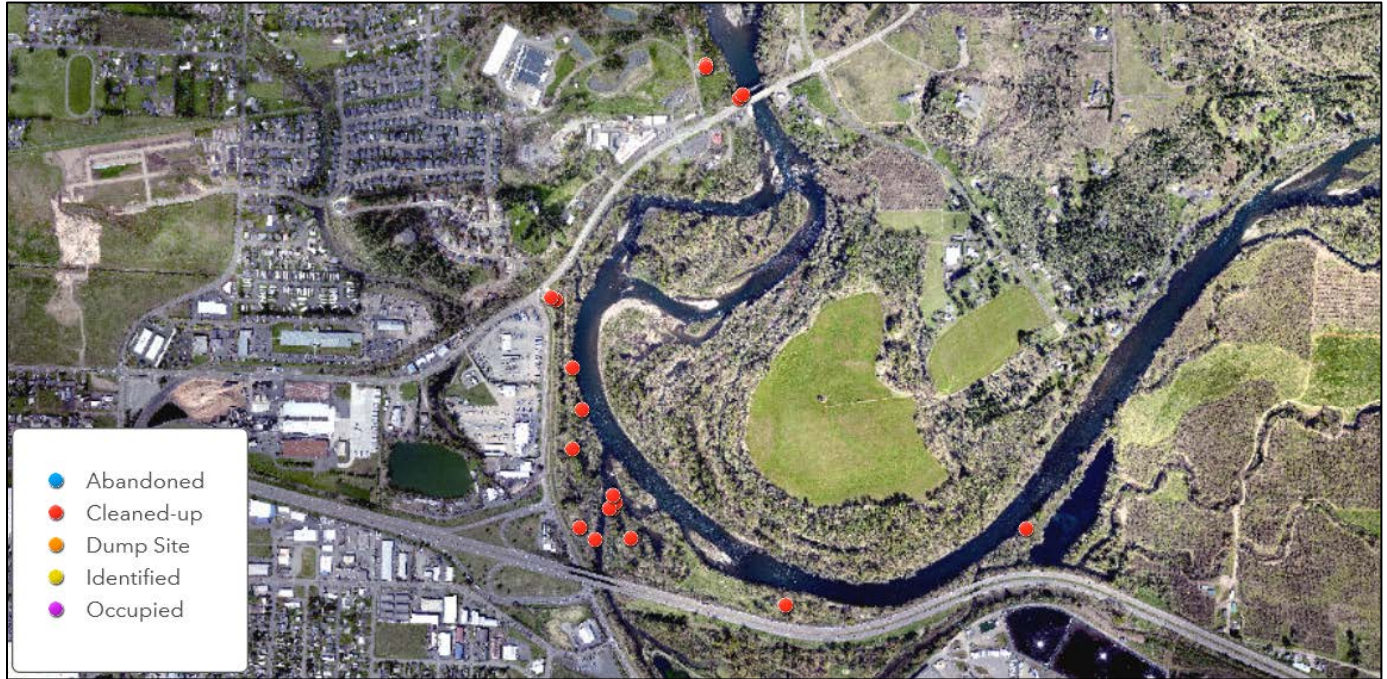
Figure 6-1: Map of Illegal Camps and Dumps, 2021

EWEB's Source Protection staff continue to partner with Willamalane Parks, City of Springfield, and Lane County to reduce the impacts of illegal camping and dumping in riparian areas along the McKenzie River immediately above EWEB's intake. Figure 6-1 shows the locations of illegal camps that were cleaned up in 2021. Figure 6-2 illustrates the downward trend of large, well established illegal camps due to the coordinated efforts of these agencies and use of the illegal camping application that identifies camps

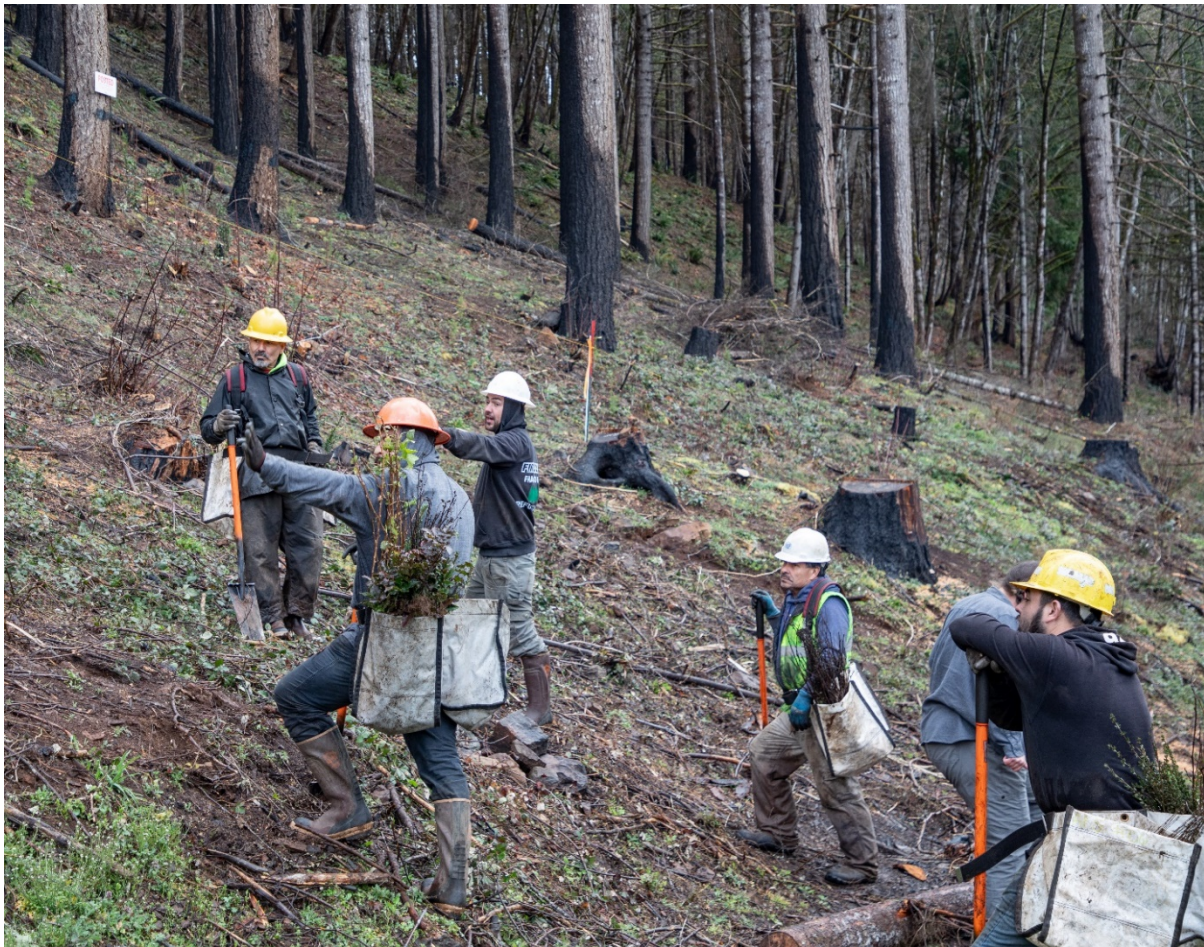
Figure 7-1: Replanting in the McKenzie Watershed, 2022

Following the 2020 Holiday Farm Fire, the Pure Water Partners program shifted its focus to carrying out restoration activities on properties impacted by the 2020 Holiday Farm Fire. This includes replanting in riparian areas, invasive vegetation removal, fire fuels reduction and erosion control. Currently the PWP is in the middle of the second winter season of replanting on private properties along the river (see Figure 7-1). This will include planting approximately 450,000 bare root trees and shrubs. In addition, the McKenzie Valley Long-Term Recovery Group that is working to help individuals and families recover from the Holiday Farm Fire has recently completed a Needs Assessment for McKenzie residents and has been able to refer additional landowners to PWP.
